# Manhole Inspection Summary

Manhole # S21MM\_027MH

Insp Date: **6/29/07 11:26 AM**

**Location** Address: **2238 FULTON AVE**

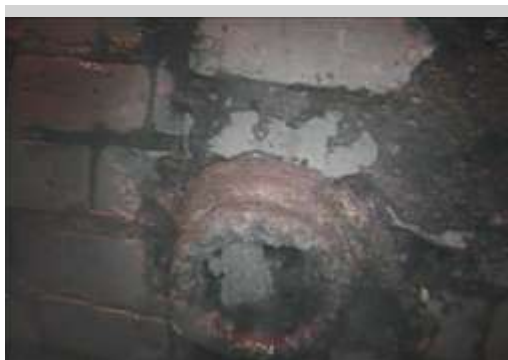
Comments **cast iron pipe about 1 foot above the bench at the i5 position, it may be a service.**

cast iron pipe at i5

CAST IRON PIPE ABOUT 1 FOOT ABOVE THE BENCH AT THE I5 POSITION, IT MAY BE A SERVICE.

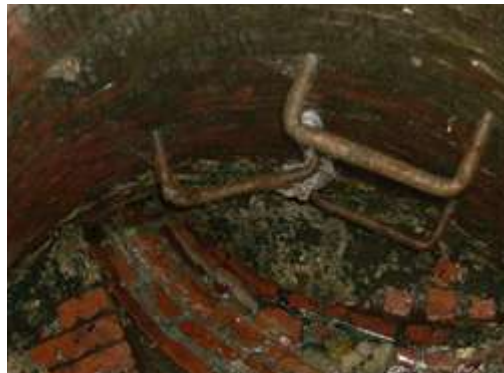
Defect 3

**Surcharge** ☒ **Evidence Of Surcharge** Depth: **4** (ft.) ☐ Active Surcharge Present

SURCHARGE EVIDENCE ON STEPS

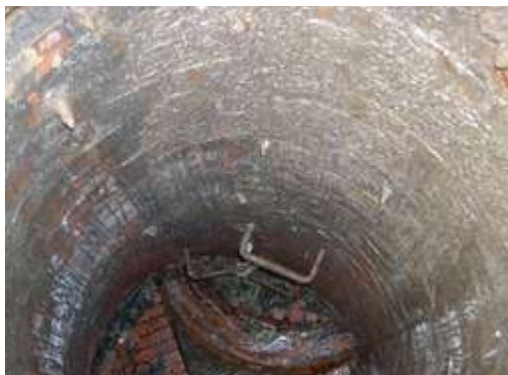
Defect 2

**Steps** Count: **3** Missing: **3** ☒ **Corroded**

CORRODED AND MISSING STEPS

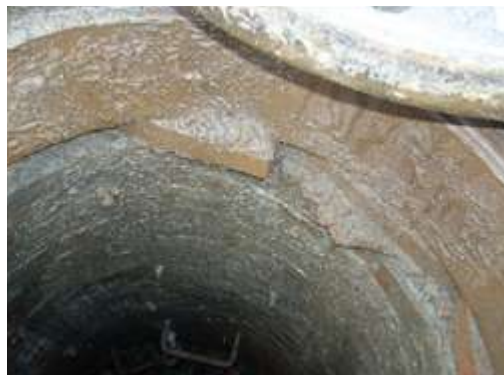
Defect 1

Condition: ☐ Sound ☐ Cracked ☐ Root Intrusion ☒ **Loose Brick** ☒ **Deteriorated**

DETERIORATED CHIMNEY WITH LOOSE BRICKS
